Vedanta – The Skorpion Mine & Smelter

A scrapheap beyond salvation, unrealistic restart plans, and a \$15m rehab provision for a hundred-million-dollar problem.

Skorpion Mine and Refinery

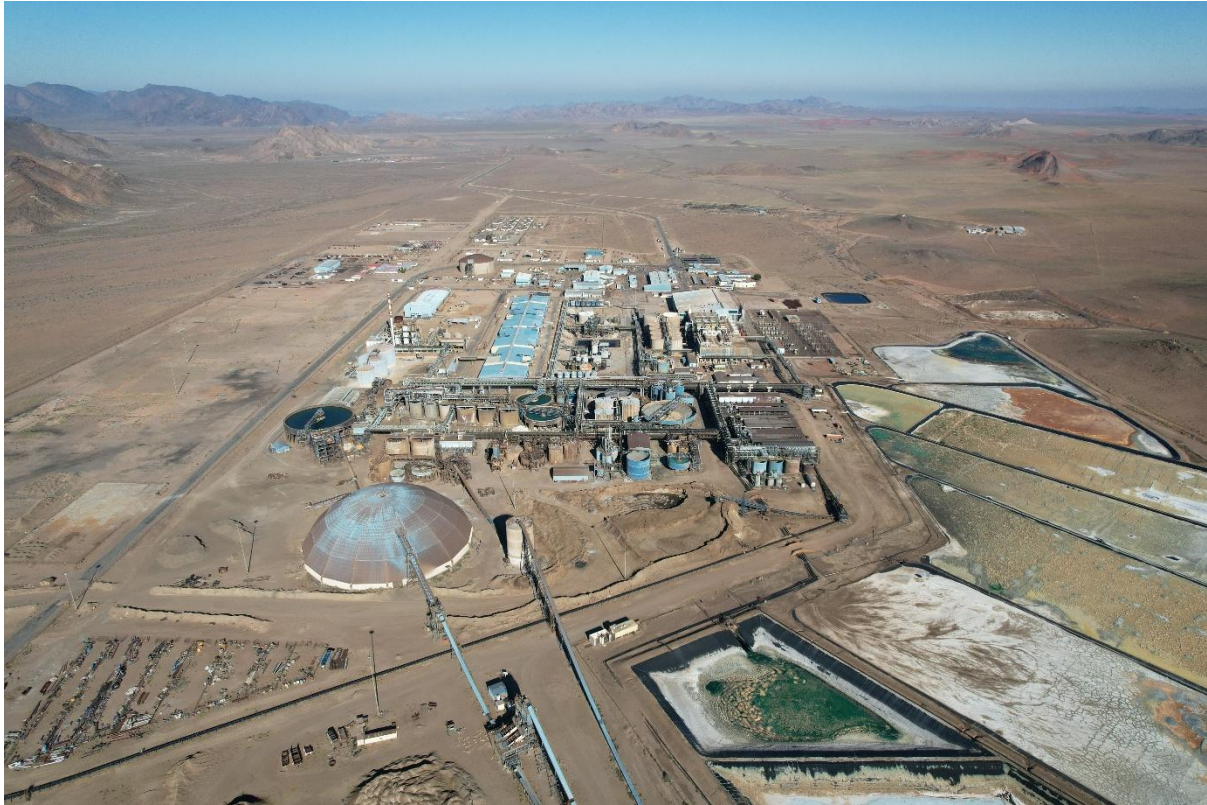
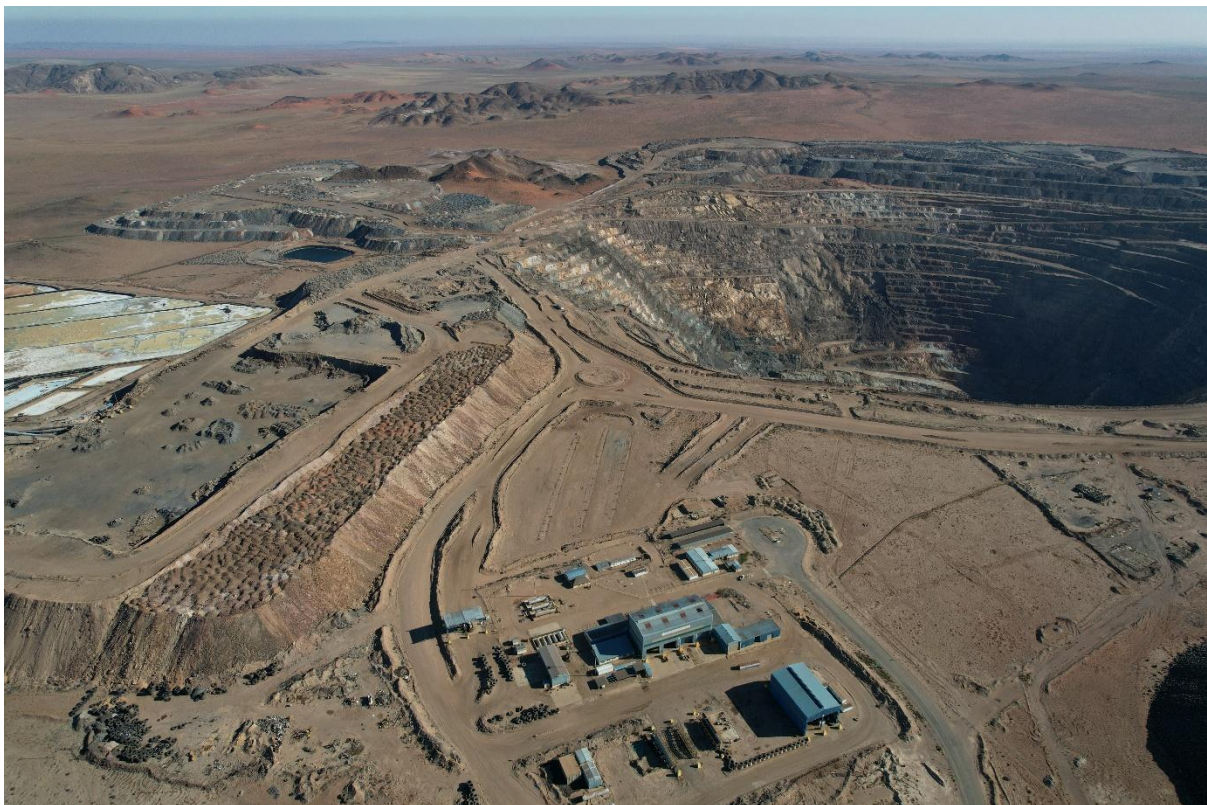
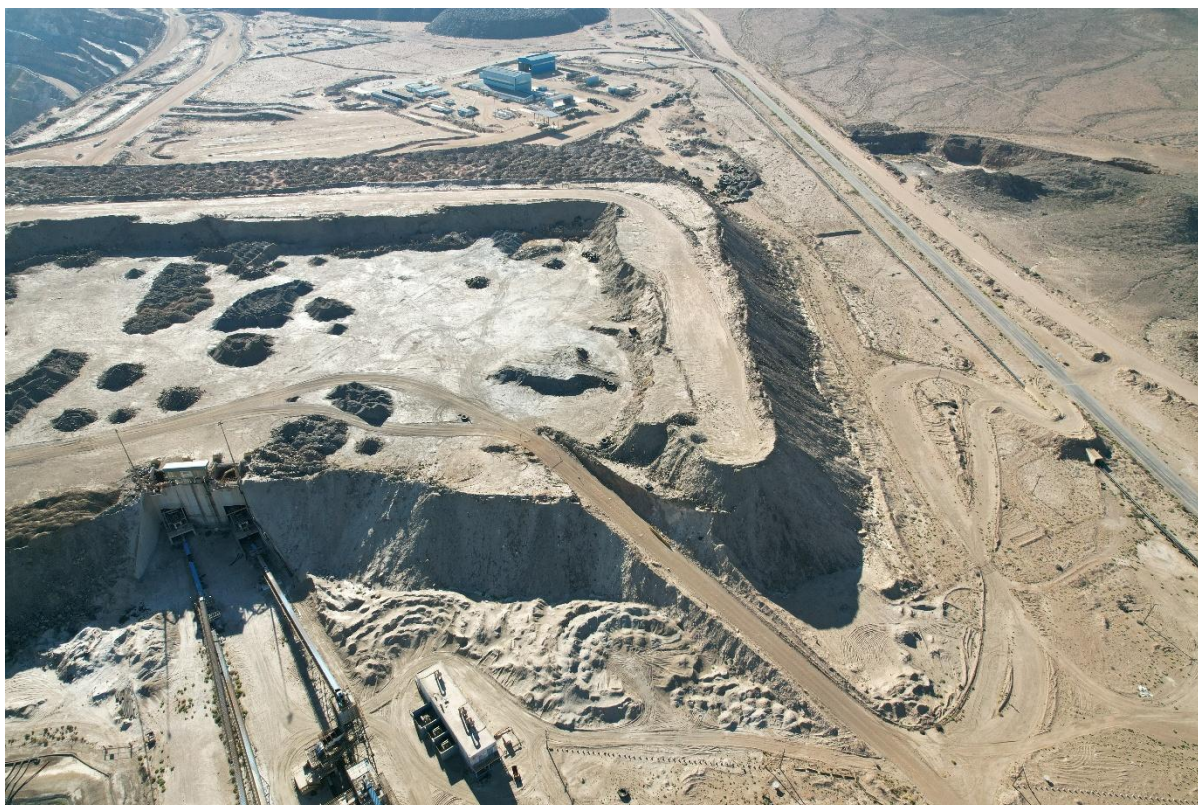
The following photos and videos were taken on a Wednesday afternoon in July. They show a complex in deep decay.

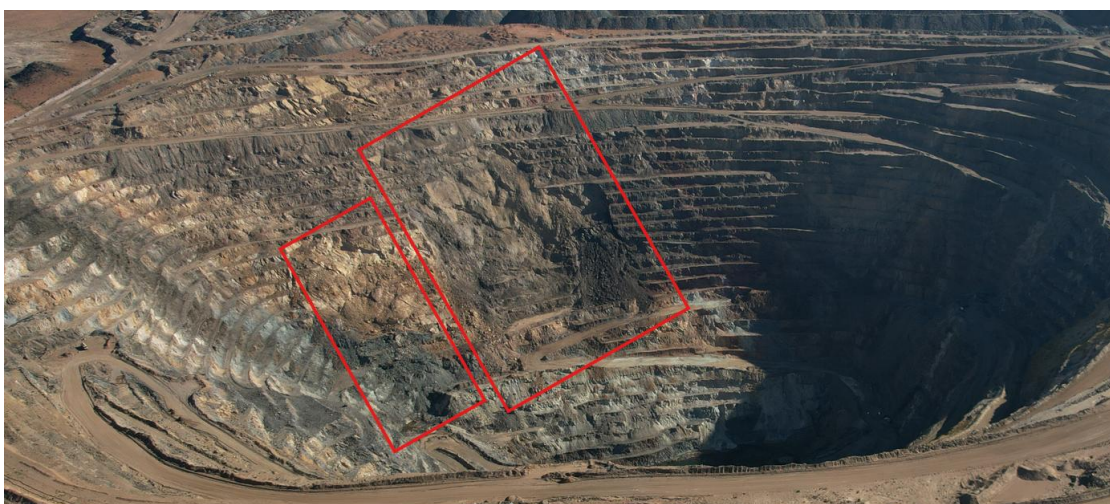
- Aerial imagery shows major slope failures and significant erosion across multiple benches.

- Water pooling at the pit bottom indicates long-term neglect of dewatering infrastructure, a red flag for both safety and operability.
- Bench access roads are degraded, with no signs of maintenance, clearing, or stability work underway.

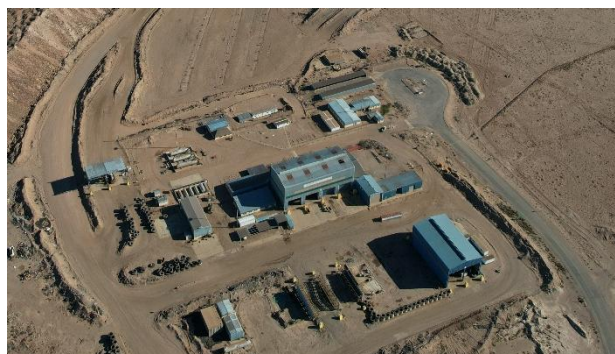
- Not a single haul truck, excavator, dozer, or even light vehicle is present across the mine, yard, or refinery complex.

- The mining workshop vehicle maintenance depot appears completely deserted and stripped of equipment.
- Equipment and vehicle staging areas are empty, with some zones being repurposed for scrap storage.

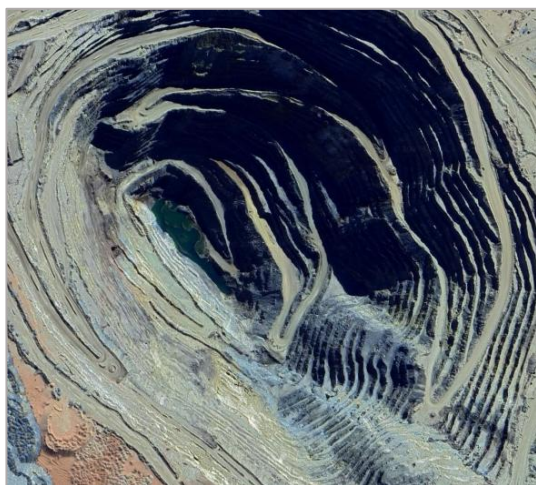
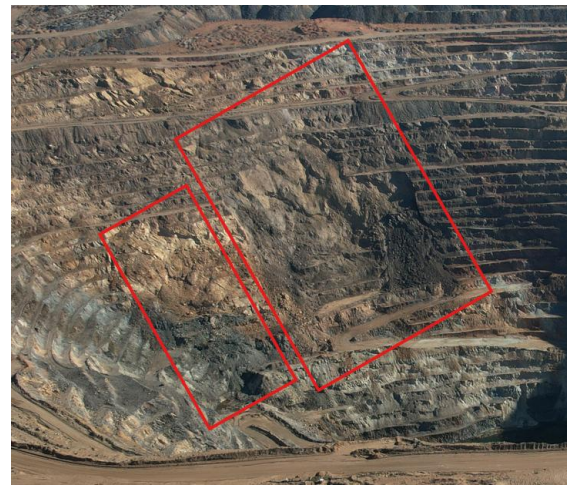
Figure 6 – Google Earth Image of Skorpion Mine dated May 10, 2023, and photo taken July 2025

- Since 2020, the mine has suffered multiple slope failures and collapsed benches making most of the pit completely inaccessible for dewatering. Satellite imagery confirms these failures have happened since May 2023.

- The bottom of the pit is flooded with no visible pumps, pipelines or drainage efforts. Satellite imagery shows the pit had already accumulated water in May 2023.

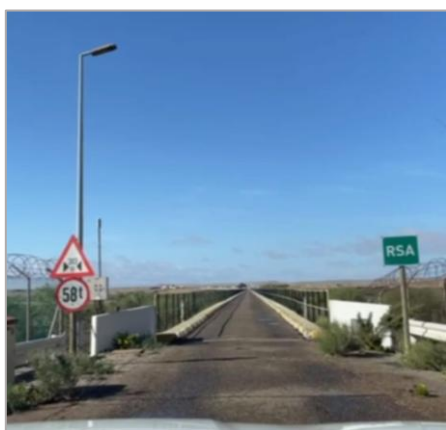
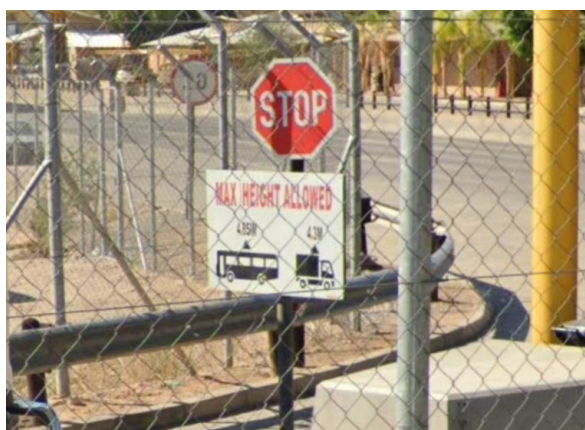
Figures 8 & 9 – The Border Crossings at Oranjemund and Vioolsdrif, respectively

Neither route can support Vedanta's proposed transport model. Linked trucks are both too tall and too heavy for the available crossings.

- The Oranjemund crossing relies on an extremely narrow single lane bridge with a maximum load limit of 56 tonnes.
- The Vioolsdrif crossing is restricted to vehicles no taller than 4.3 metres.

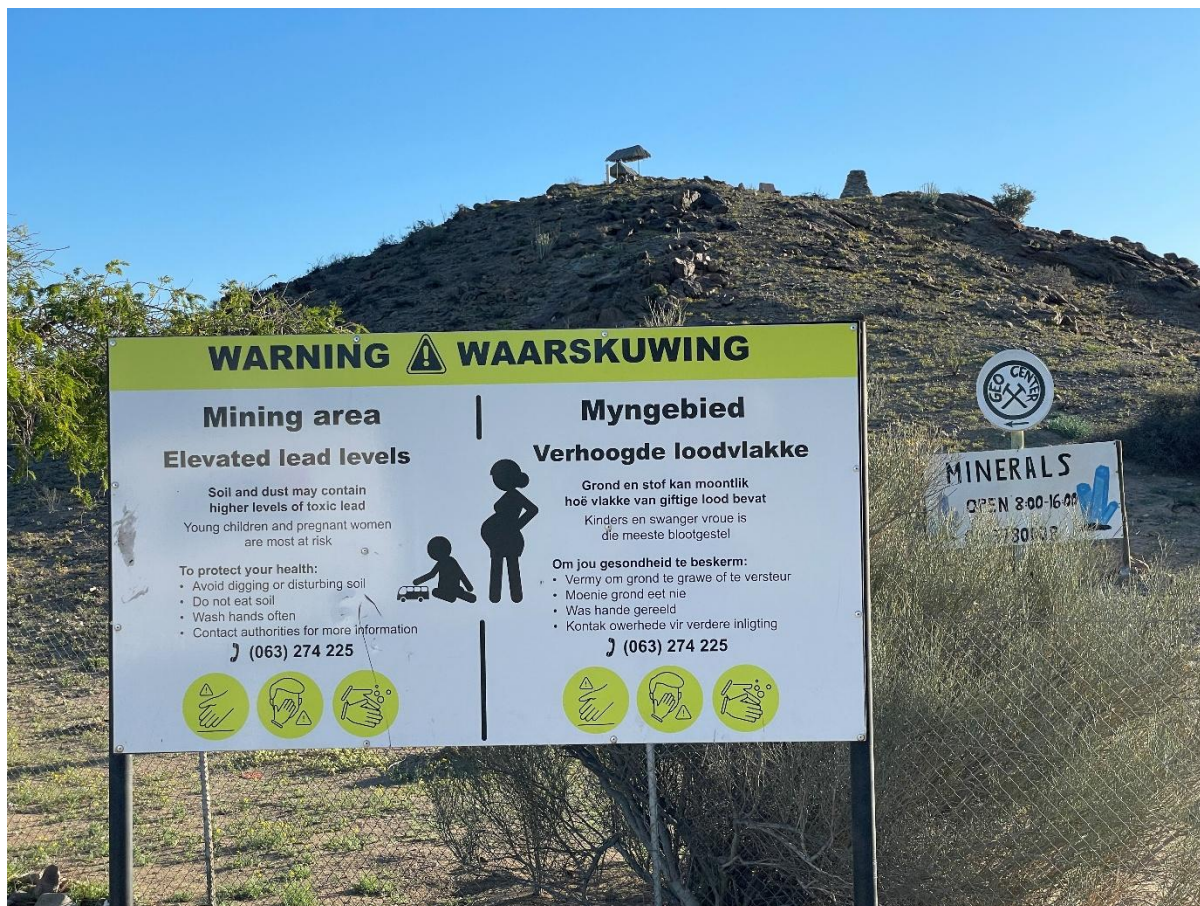
The township of Rosh Pinah, which formerly housed Skorpion employees, has documented lead contamination linked to local mining activity, including Skorpion and the Rosh Pinah mine.

- Our team noted that sheens of toxic lead dust were visible under doors every morning in Rosh Pinah.
- Interviews with workers and engineers described Rosh Pinah as amongst the worst living conditions they had experienced, with many citing health hazards as the reason for high turnover.
- The Township has not undergone any rehabilitation. Instead, ownership was transferred to the state under the pretext of addressing a “housing shortage”, despite Rosh Pinah’s isolation, lack of employment opportunities and proximity to contaminated mining areas.
